APPENDIX Q PHOTO LOGS -BETA SITE DRILLING INVESTIGATION (BS 3,4,5,6)

Project 1007 | MPCA

Twin Cities East Metro, Minnesota

Beta Site Drilling Investigation (BS 3,4,5,6)

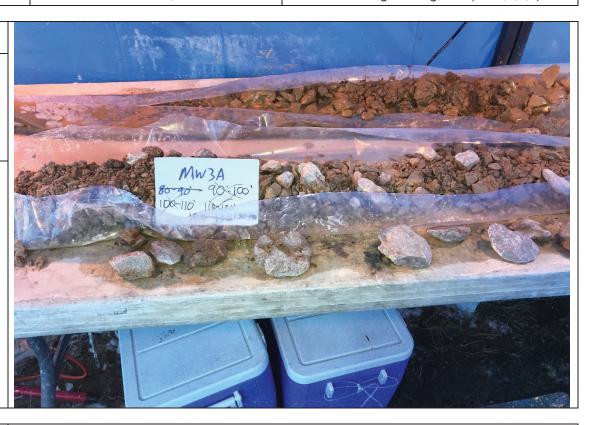
MW3A at 130-140 feet below ground surface (bgs) in the Shakopee Formation. The Shakopee was first encountered in MW3A at 74 feet bgs and in MW3B at 79 feet bgs.

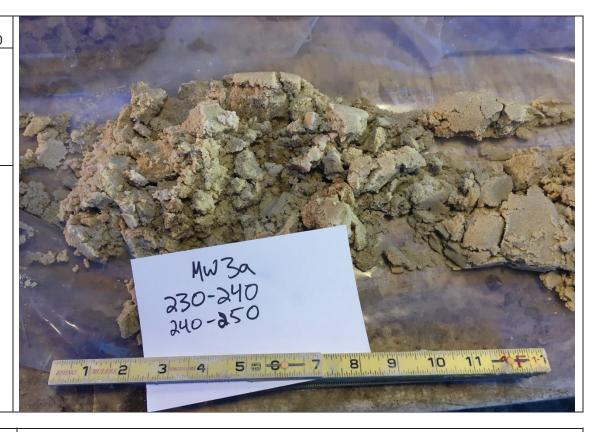
MW3A from 240-250 feet bgs. The Jordan-Oneota contact occurred at 221 feet bgs. Pictured is a typical segment of the core from the Jordan Sandstone.

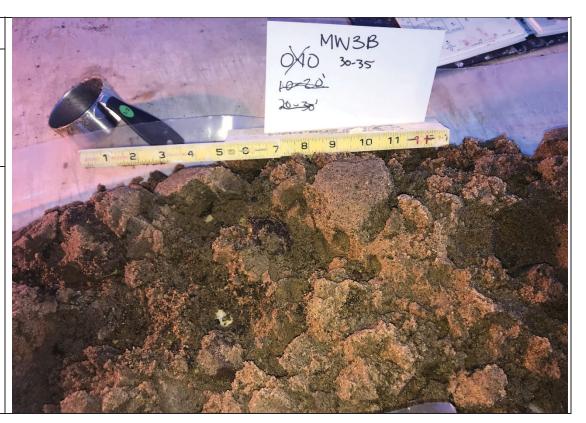
Photo No. 5

Soil from MW3B at 30-35 feet bgs. A composite soil sample was collected at 31-35 feet bgs to correspond with the groundwater sample collected from the same interval.

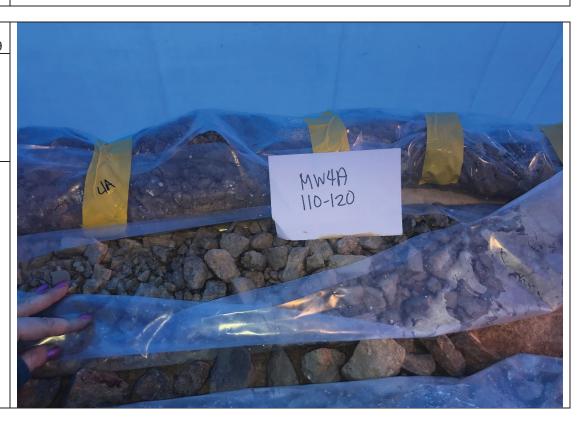
Photo is of the Shakopee Formation in MW4A. The contact between unconsolidated soil and the Shakopee occurred at 90 feet bgs.

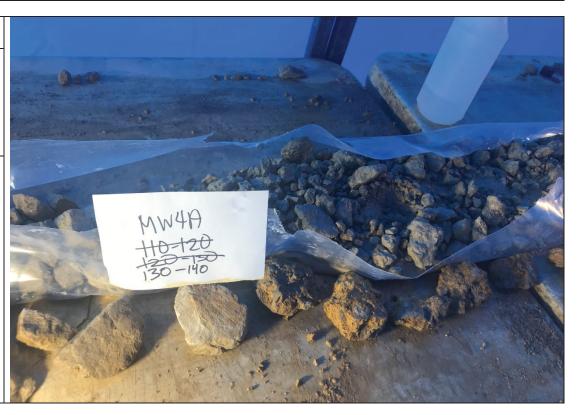
Photo is of the contact between the Shakopee and the Oneota Formations which occured at 133 feet bgs.

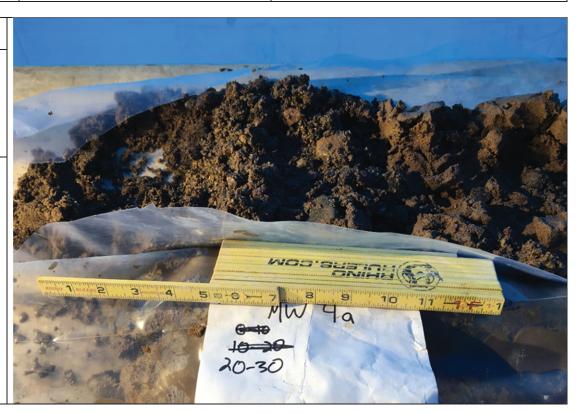
Two discrete soil samples were taken from 20-30 feet bgs: one was collected at 20-21 feet bgs to target the silty sand directly above the water table, the second was collected at 20-23 feet bgs to target the silty sand directly below the water table.

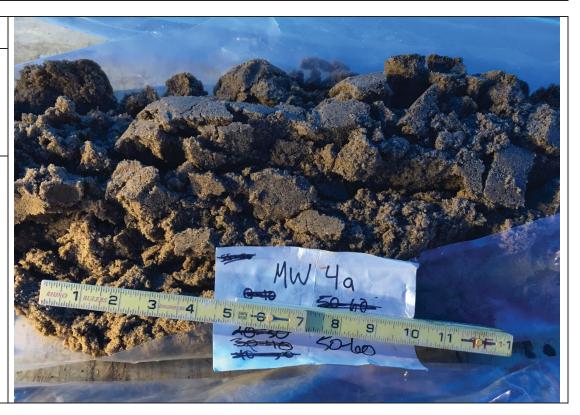
A discrete soil sample comprised of fine-grained sand was collected from the 51-52 feet bgs interval.

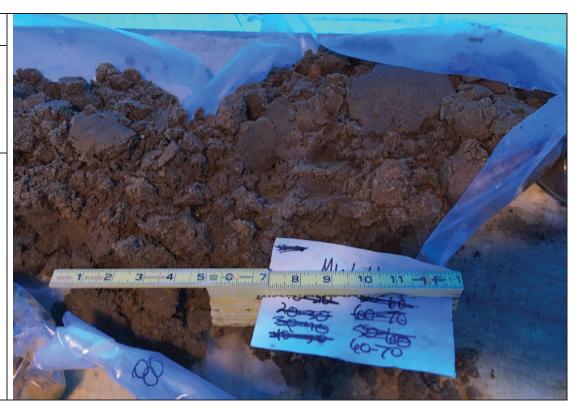
Photo No. 15 **Date:** 12/13/2019

A discrete soil sample was collected from the 68-70 feet bgs interval. The soil sample contained a larger percentage of fine sand compared to shallower intervals.

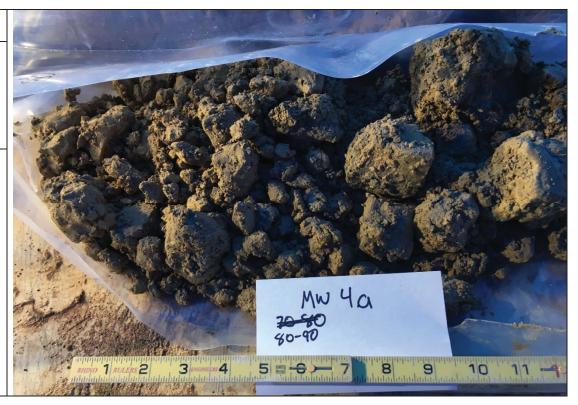
A discrete soil sample was collected from 80-81 feet bgs. The sample collected was weathered bedrock consisting of gravel-sized dolostone with sand.

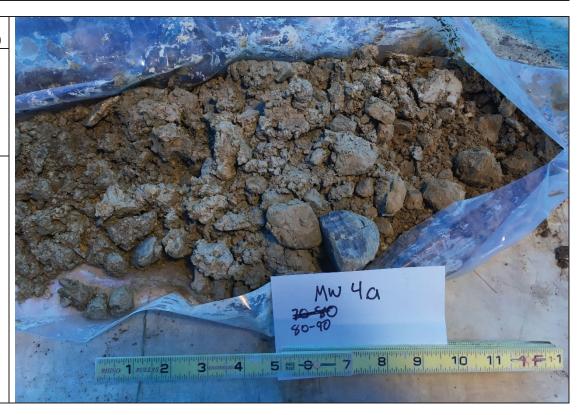
Photo No. 19 **Date:** 12/13/2019

The soil directly above the bedrock contact at 88-89 feet bgs consisted of sand with gravel and was sampled.

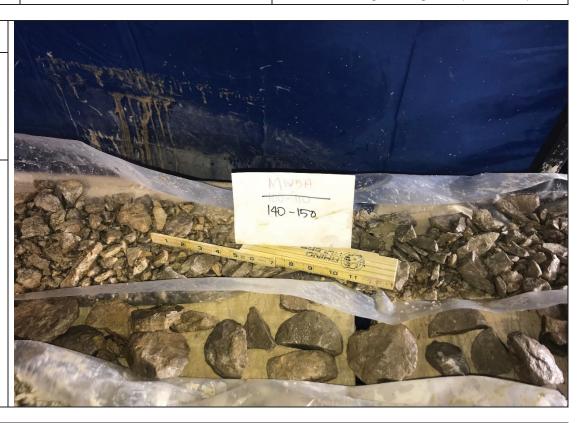
Photo No. 21 **Date:** 12/3/2019

The image shows the Oneota Formation in MW5A. The contact between the Shakopee and Oneota Formations occurred at 140 feet bgs.

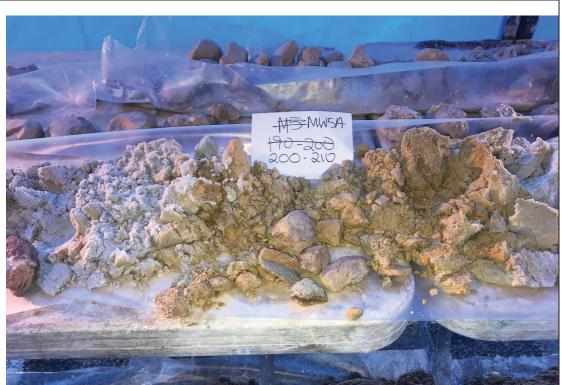
Photo No. 22 **Date:** 12/4/2019

The Jordan Formation in MW5A and the typical color variation, ranging from white to tan, that is commonly observed. The contact between the Oneota and Jordan occurred at 203 feet bgs.

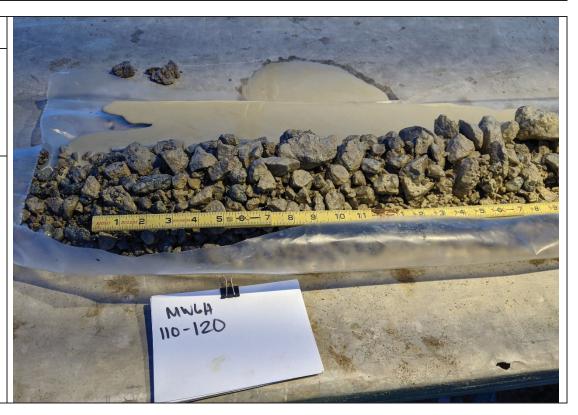
Photo No. 29 **Date:** 11/12/2019

The Shakopee Formation at MW6A. The contact between the unconsolidated material and bedrock occurred at 110 feet bgs.

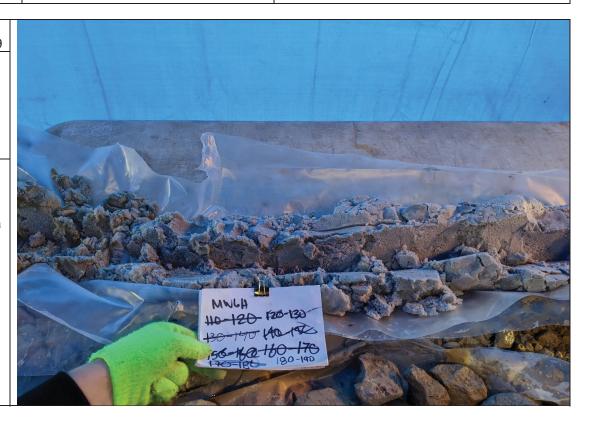
Photo of the Jordan Formation in MW6A. The contact between the Oneota and the Jordan Formations occurred at 182 feet bgs.

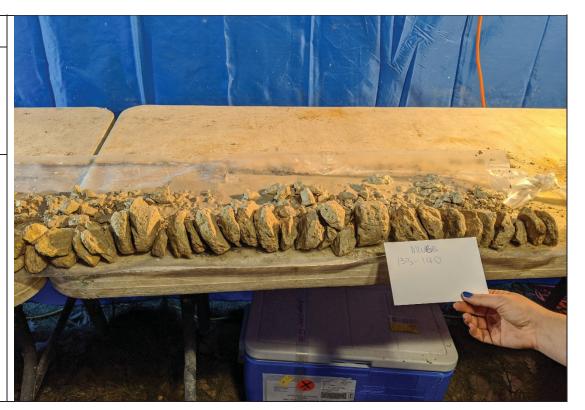
Photo No. 36 **Date:** 11/19/2019

The first encountered bedrock unit in MW6B (the Oneota Formation).

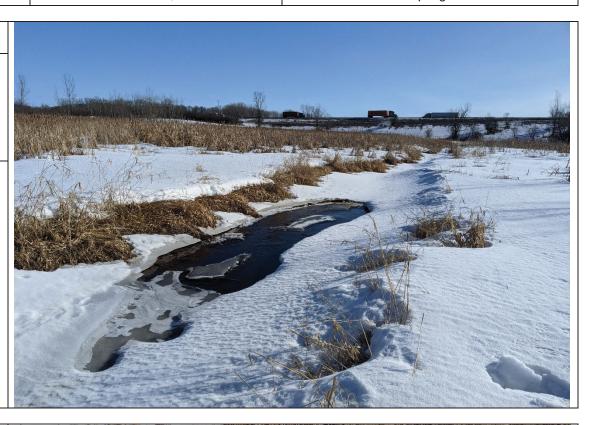
The image shows the sampling location with highway 694 to the east. Low stream flow was observed in the channel, which was partially covered by layers of snow and ice.

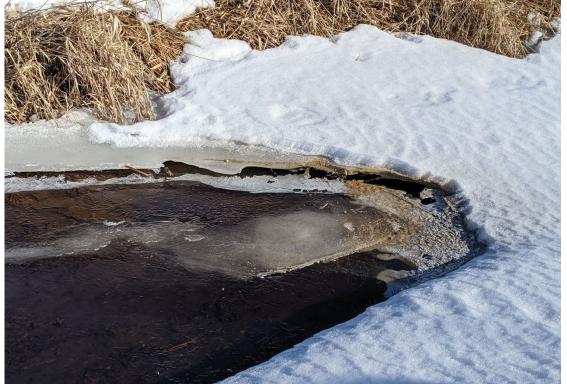
Photo No. 2 **Date:** 2/24/2020

Frozen organic foam with a light tan/orange color was observed downgradient of the outlet pipe that discharges water from the Oakdale Disposal Site to the east side of Hadley Ave.

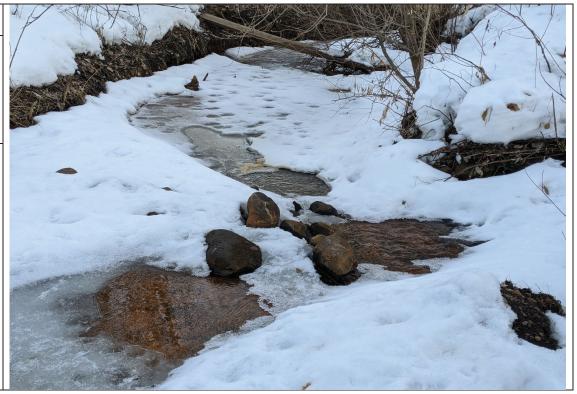
A small accumulation of partially frozen foam with a brown/tan color was observed and sampled in this location. Ice within the creek channel was thin and discontinuous.

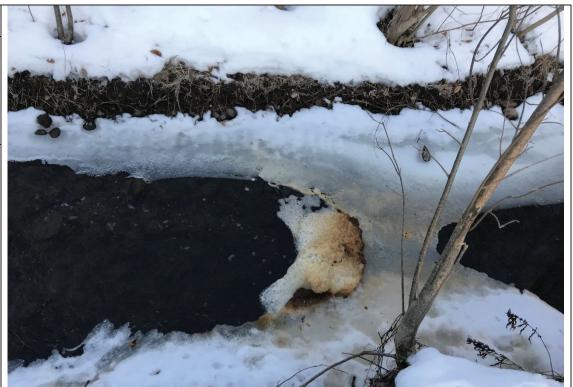
Photo No. 12 **Date:** 2/24/2020

Foam accumulating on an ice dam in the center of the creek was observed and collected upgradient of the surface water sample from this location.

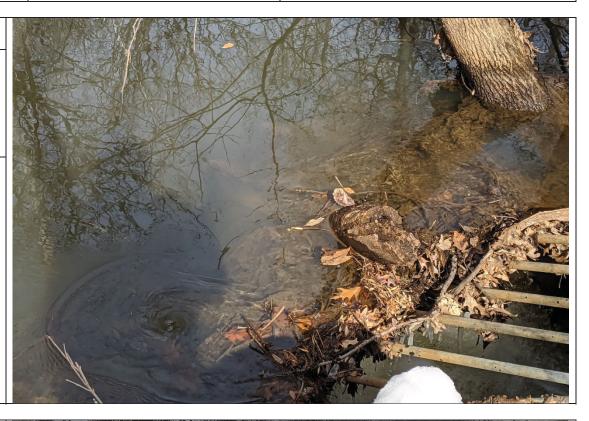
The image shows detritus from upstream of the channel impeding the flow of water into the culvert. The creek was turbid and the channel bottom was not visible from the bank.

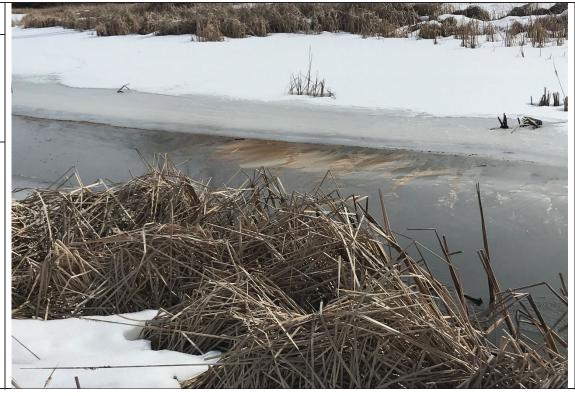
Potentially frozen foam was observed east of the surface water sampling location. An orange/light brown discoloration was seen along the bank.

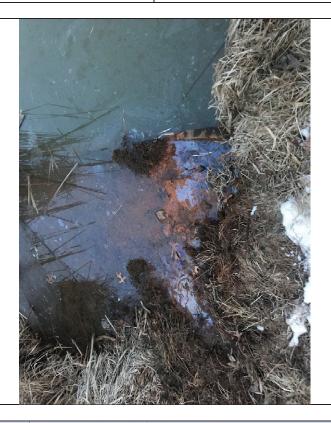
A biosheen was observed on the surface of the water in the sampling area.

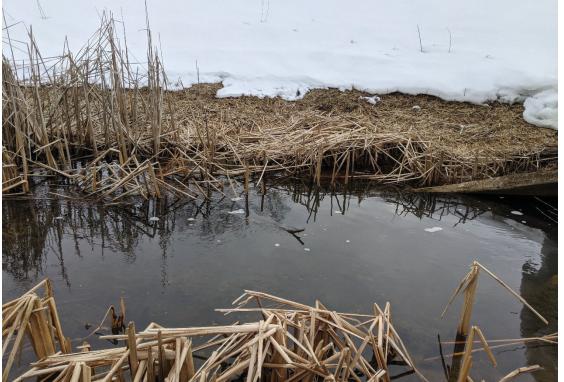
Photo No. 22 **Date:** 2/25/2020

This sampling area is located at the corner of Manning Ave and 12 St. N. Foam was observed floating downstream of the outlet pipe and stream flow was low.

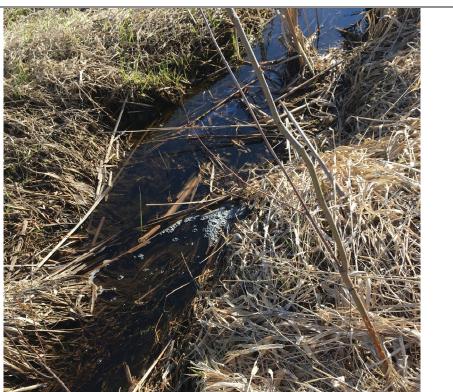
Looking downstream at the sample location, fresh foam was observed collecting near grasses and reeds along the bank. The foam consisted of large white bubbles.

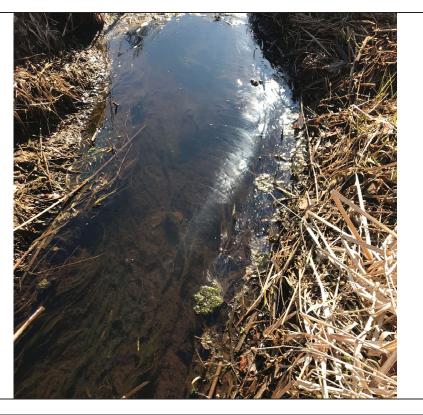
The image shows the area where wetland samples were collected. Biosheen was observed on the water surface.

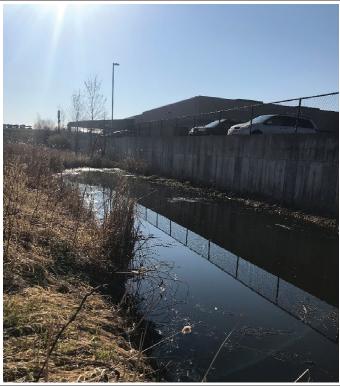
The image shows the sampling location, looking southeast towards Menards at the stormwater ponds. Biosheen was observed in multiple locations.

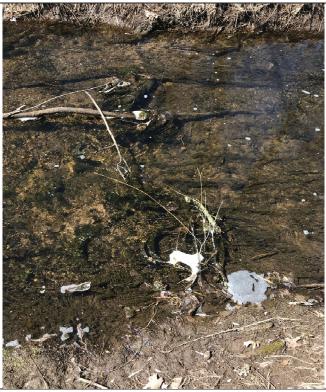
Photo No. 14 **Date:** 4/23/2020

Fresh foam was observed collecting along twigs and grasses in the sampling location.

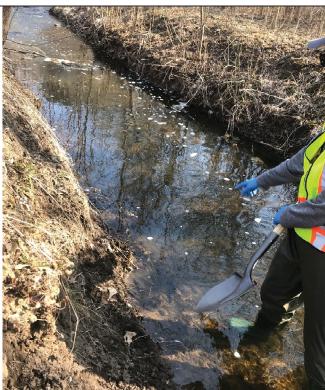
Freshly generated, thin foam was observed on the surface of the stream along the far bank. Flow speeds were moderate to high in this location.

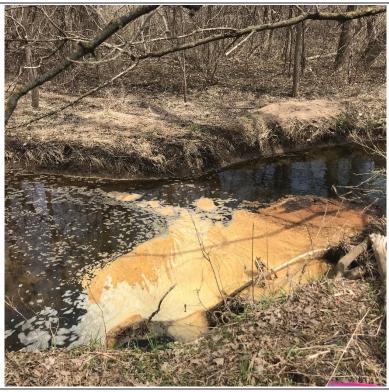
Photo No. 18 **Date:** 4/23/2020

A large accumulation of foam was observed at the sample location. The foam was thin and primarily an orange color with patches of white and dark brown foam. Two foam samples were collected. One sample consisted of freshly generated foam that was actively accumulating on the left side of the image; the other sample consisted of older foam from the right side of the image.

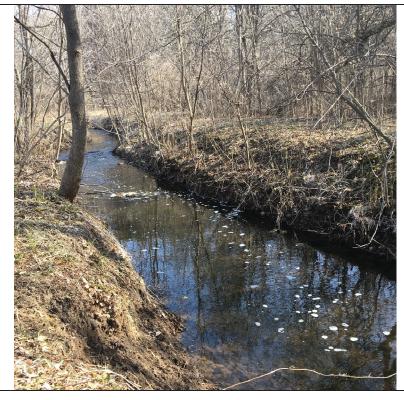
Foam floating downstream was observed along the far bank and accumulated near leaves and twigs within the stream channel. The accumulate foam was 2-3" tall and fluffy. The sediment sample collected from this sample location consisted of 15% poorly graded fine gravel, 60% medium subrounded sand, 15% silt, and 10% organics.

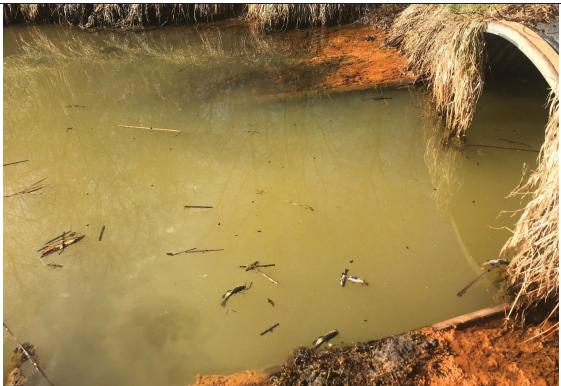
Photo No. 28 **Date:** 2/27/2020

Stagnant, very murky water was observed near the culvert at this sample location.

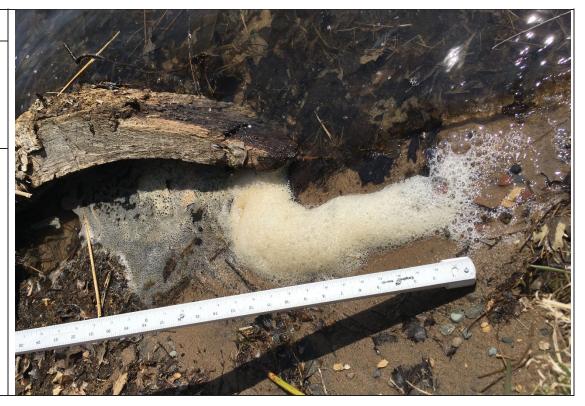
Fresh foam was observed on the beach of the canoe launch at this sampling location. The accumulated foam was approximately 1 inch tall by 5 inches wide.

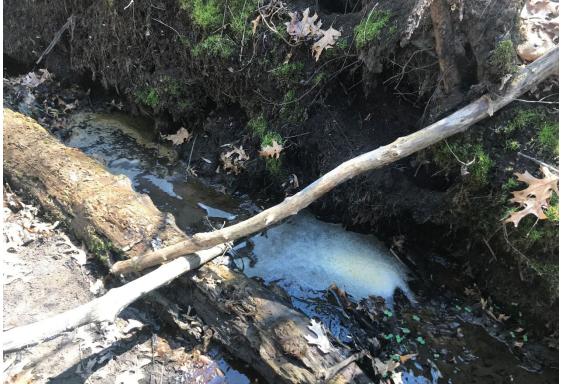
Photo No. 38

Both old and freshly generated foam was observed at the sample location. The accumulation of fresh foam was a fluffy, off-white color and was approximately 1-inch thick. The accumulation of older foam was thin and an orange color.
