**Figure 1a**  
**Project Location**  
**Six-Month Investigation Progress Report**  
**(November 11, 2019 - May 15, 2020)**  
**Project 1007**  
**Minnesota Pollution Control Agency**

**Figure 1b**  
**Project Overview**  
**Six-Month Investigation Progress Report**  
**(November 11, 2019 - May 15, 2020)**  
**Project 1007**  
**Minnesota Pollution Control Agency**

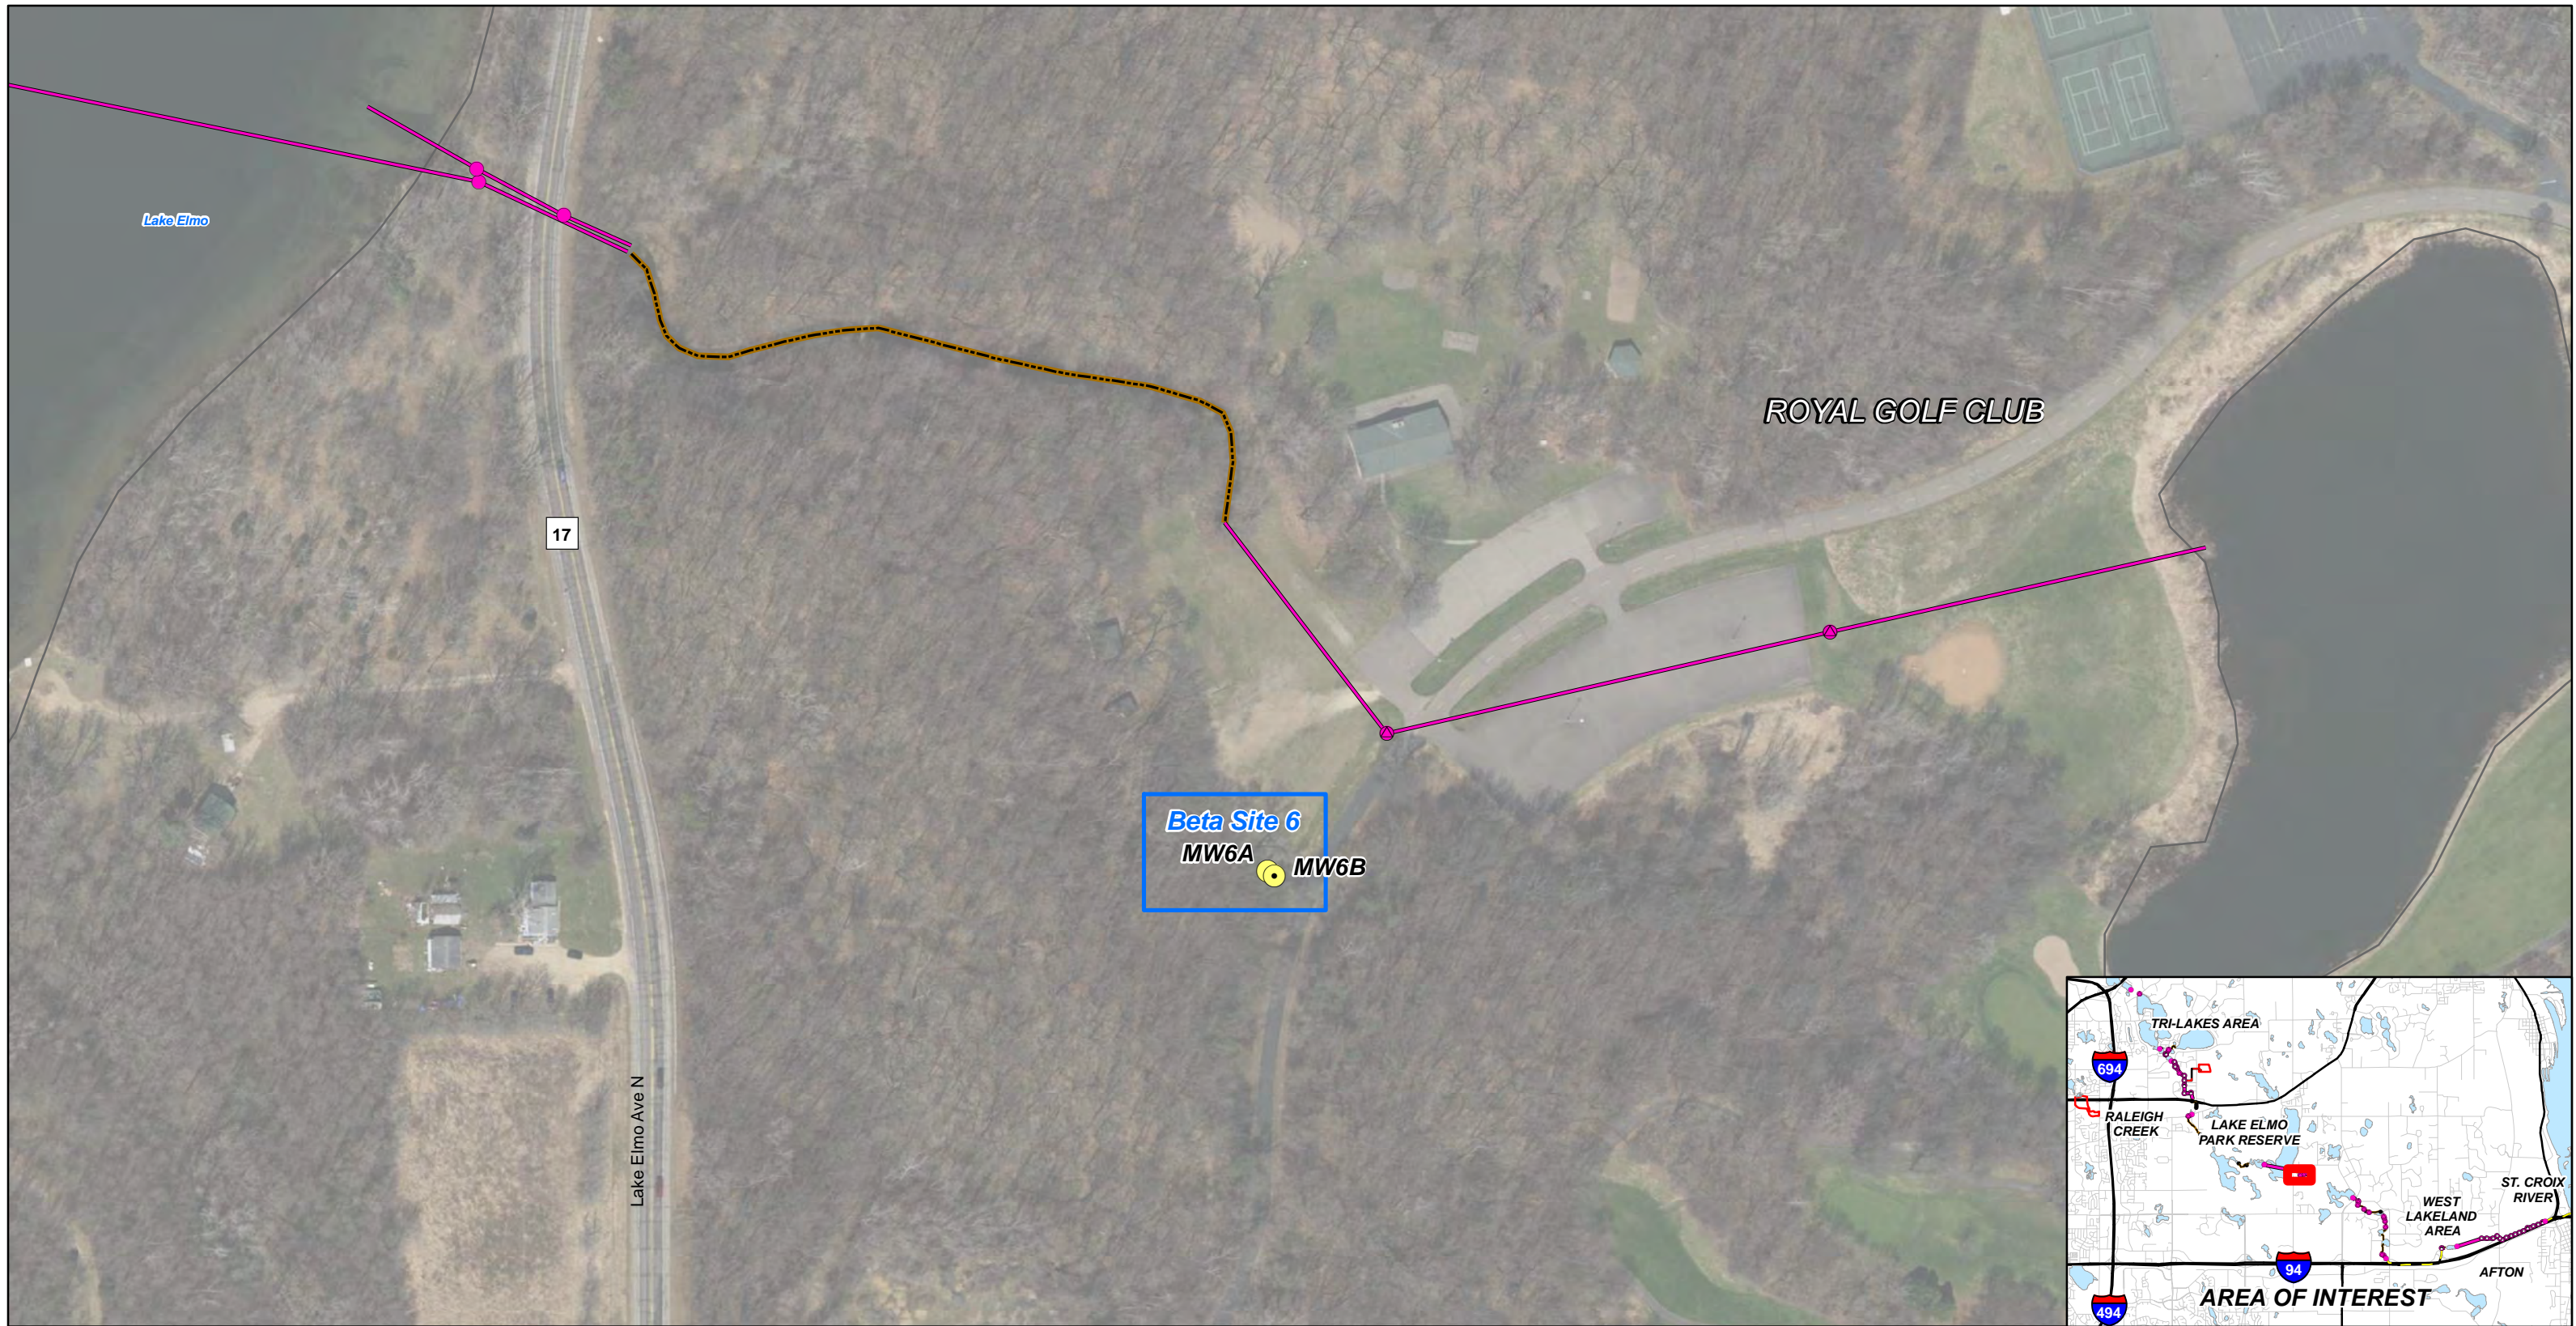
**Figure 3-1b**  
**Beta Site 6 Location Map**  
**Six-Month Investigation Progress Report**  
**(November 11, 2019 - May 15, 2020)**  
**Project 1007**  
**Minnesota Pollution Control Agency**
