#### MINNESOTA POLLUTION CONTROL AGENCY

#### Project 1007 – Progress Update

January 14, 2020

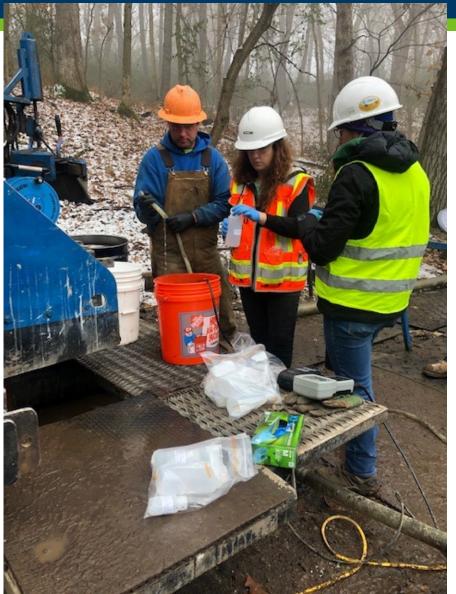
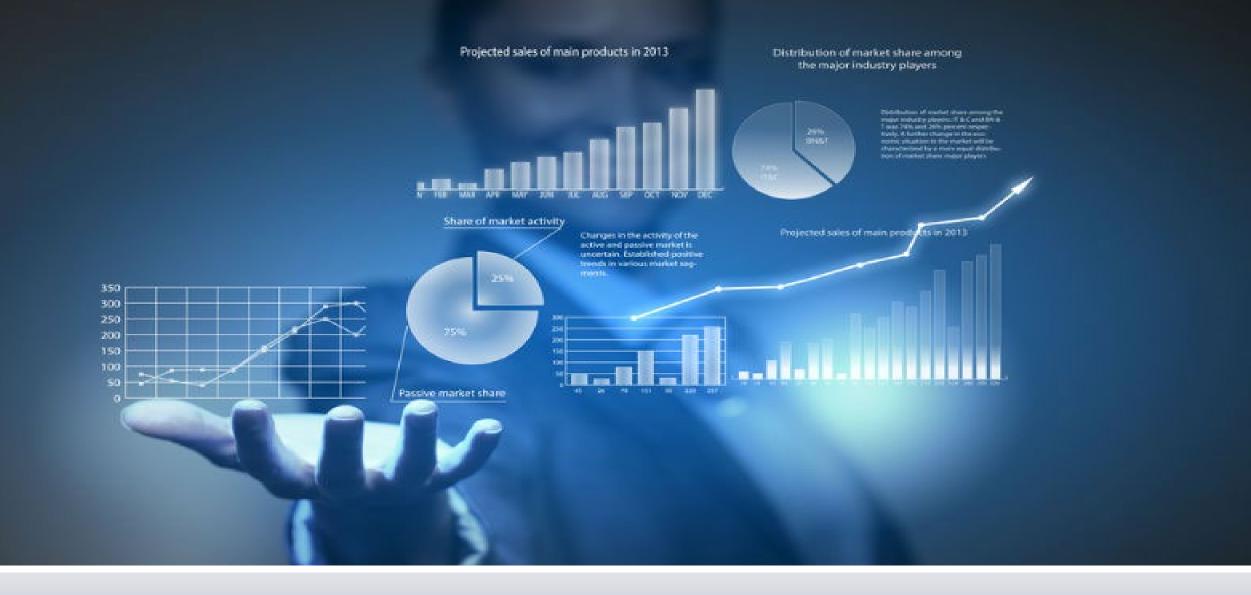
#### Beta Investigation Sample Collection Groundwater and Soil Strategy

- Groundwater and soil samples in surficial glacial units *while* drilling.
- Sampling depth intervals based on soil cuttings from the adjacent deeper well.
- Groundwater samples collected at:
  - Top of the water table
  - Intervals of finer-grained and coarser-grained soils
  - Immediately above first bedrock formation
- Soil samples collected at:
  - Intervals coincident with groundwater samples
  - Zone immediately above water table and first bedrock
  - Any potential confining layers

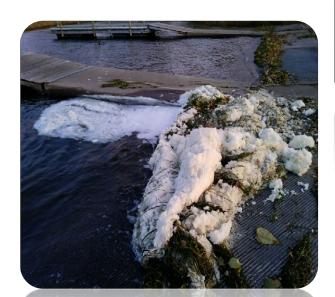
PFAS foam on a large creek

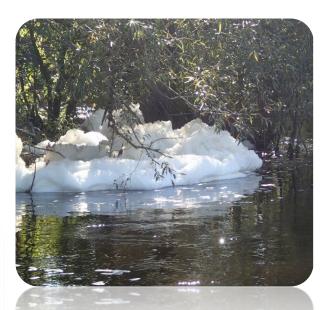
River with previously low level PFAS

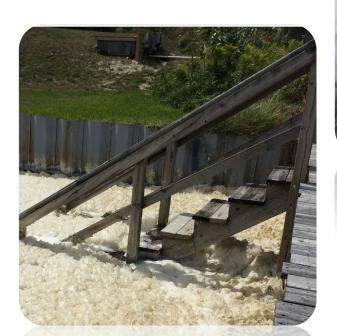
Dock on a lake with nearby sources.

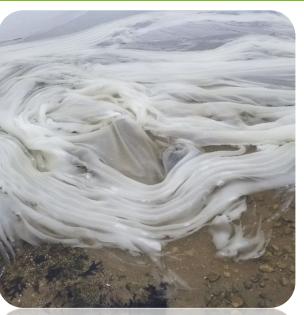
Frozen Foam

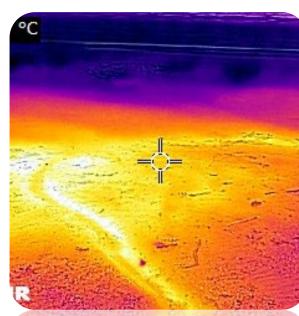
# Infrared Camera imaging for source area seeps.

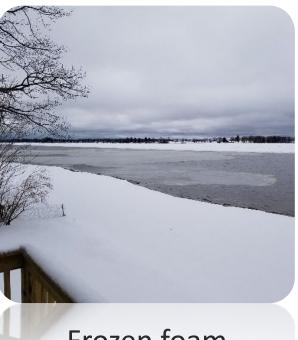
# Frozen foam islands
