APPENDIX Q PHOTO LOGS -BETA SITE DRILLING INVESTIGATION (BS 3,4,5,6)

Project 1007 | MPCA

Twin Cities East Metro, Minnesota

Beta Site Drilling Investigation (BS 3,4,5,6)

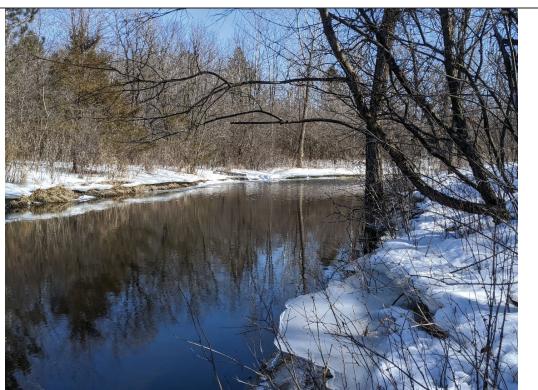
Patches of thin ice sheets were observed along the channel banks. Stream flow was low.

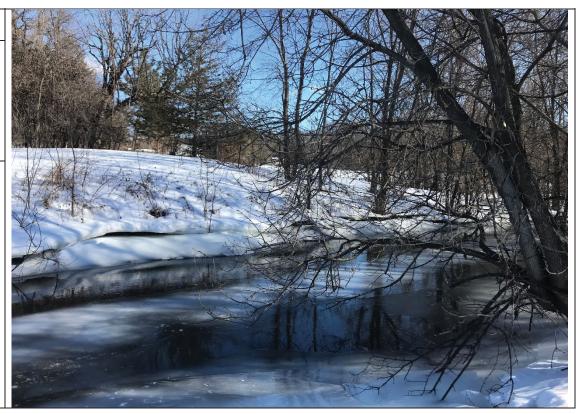
Photo No. 29 **Date:** 2/26/2020

Large but thin sheets of ice covered the banks.

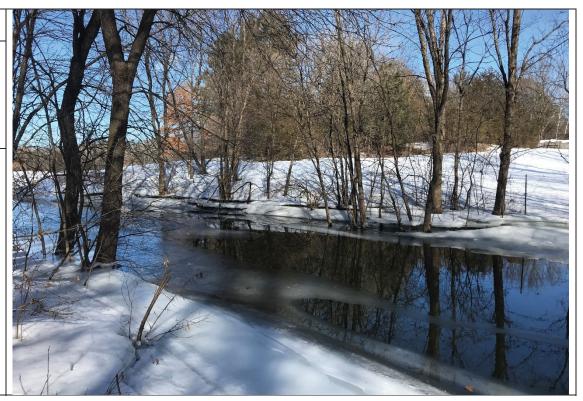
Photo No. 30 **Date:** 2/26/2020

Very thin, discontinuous ice that was occasionally covered by a layer of snow was observed at this sample location.

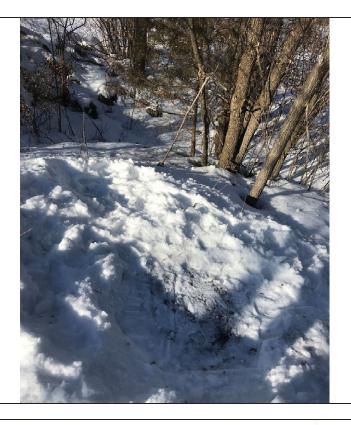
Photo No. 31 **Date:** 2/26/2020

The image shows the manhole at the surface water sampling location, looking east.

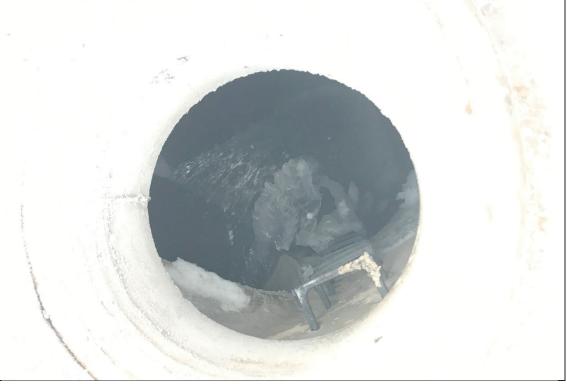
Photo No. 32

The image shows the manhole at this sampling location. Water flow was very high inside the manhole structure.

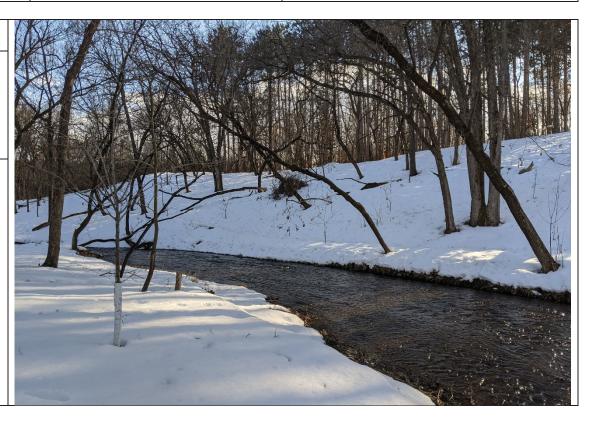
Photo No. 33

Stream flow was moderate to high in this sampling area and no ice covered the water surface.

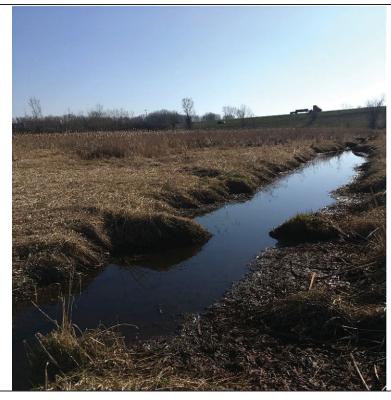
The image shows the sample site location looking east towards highway 694. The sediment sample was collected from the center of the channel.

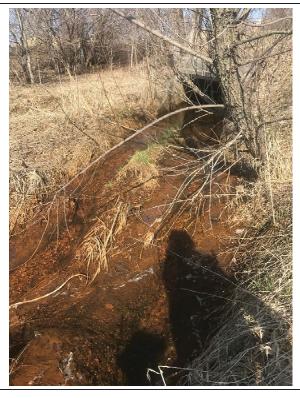
Photo No. 5

The image shows the culvert upstream of the sample location. A thin film of foam collected along the banks and grasses in the center of the channel.

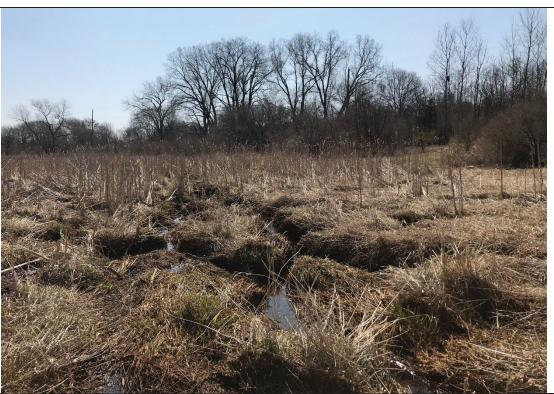
Downstream of the sample location, the stream channel branches into several secondary channels.

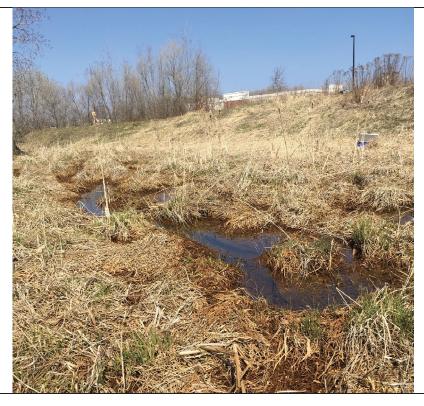
This photo was taken upstream of the main channel. The sediment sample was collected from a secondary channel.

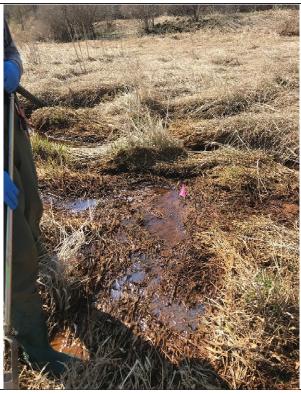
The image shows the sampling location within a secondary channel. Shallow water covered the sampling area.

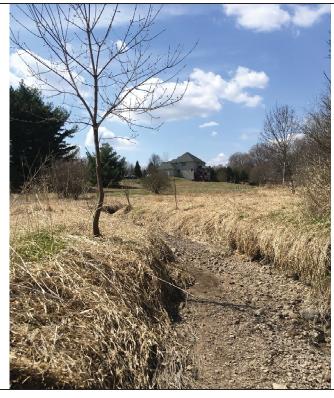
The image shows the dried creek bed at the sample location. Banks were eroded and the creek bed contained large cobbles and small boulders.

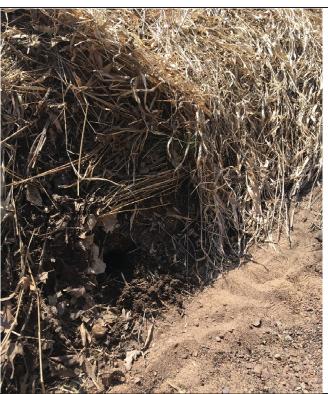
The image shows the creek bank where composite sediment samples were collected. Dead grasses were observed along the banks of the creek bed.

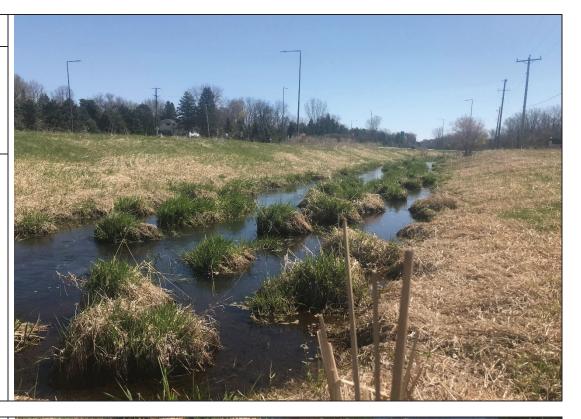
The image shows the sampling location looking east towards the intersection of Stillwater Boulevard and Highway 5. The sediment sample was collected from one of many wetland hummocks present.

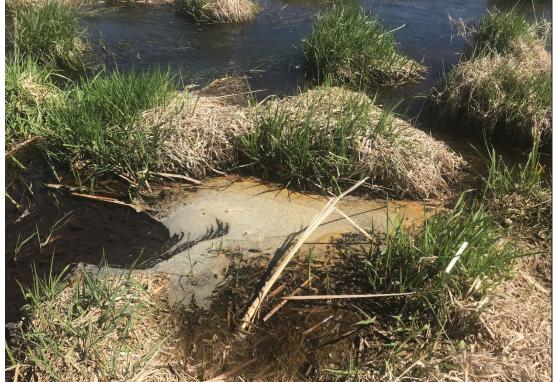
Photo No. 12 **Date:** 4/30/2020

Thin foam collected on the surface along the grasses and reeds near the bank at the sample location. The culvert immediately upstream of this location is the likely source of turbulence creating the foam.

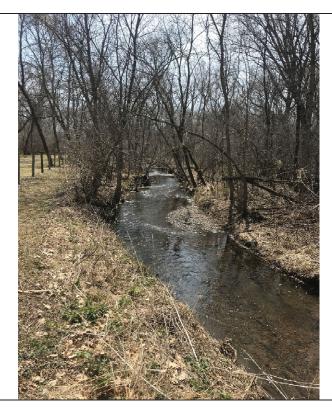
Moderate flow with light ripples was observed in the creek at the sampling location.

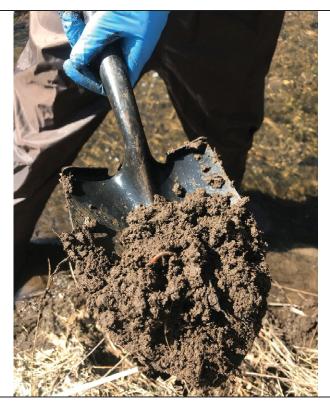
Sediment collected at the sampling location comprised of 55% silt, 30% fine to medium sand, and 15% organics.

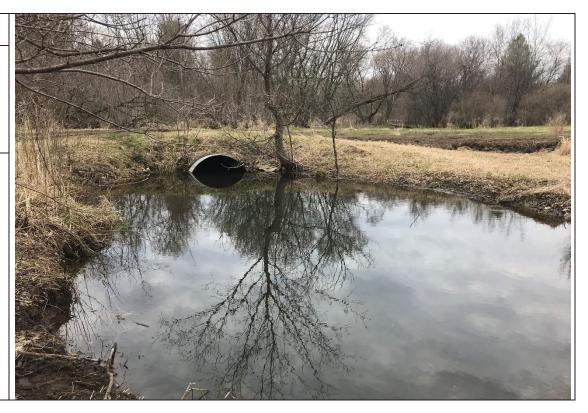
The image shows the culvert located at the sampling location where the water is notably calm. The sediment sample consisted of approximately 60% sub-angular gravel, 30% coarse, sub-rounded sand, and 10% medium sand.

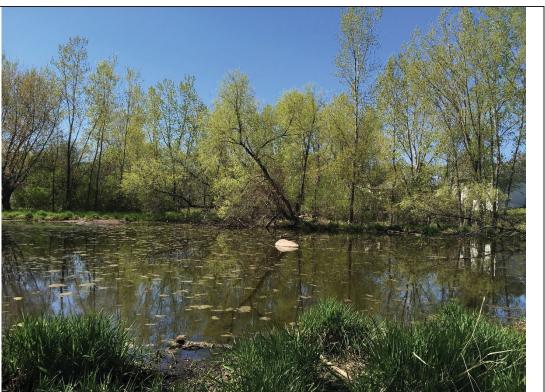
Grasses and trees were present along the wetland bank and floating algae was observed on the surface of the wetland. The sediment sample collected from 0-6" consisted of 50% low plasticity silt, 40% organic matter, and 10% fine sand.

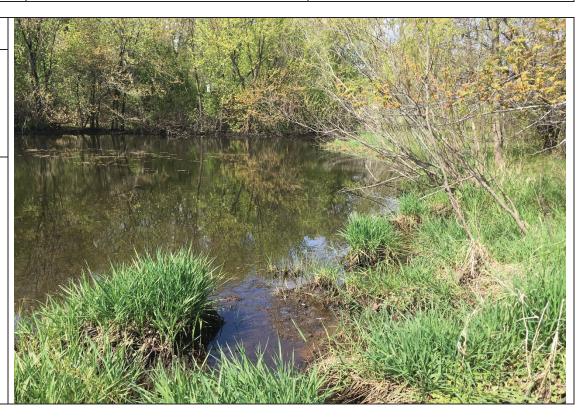
The wetland banks were primarily comprised of short to medium grasses and partially mature trees and shrubs. Algae was also observed floating on the wetland surface.

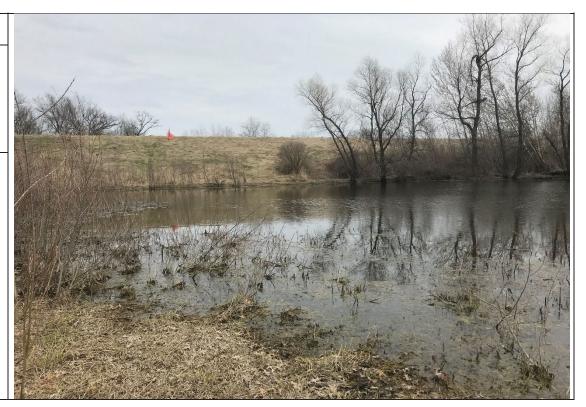
Photo No. 22 **Date:** 4/23/2020

The water at this sample location was slightly murky and contained a slightly organic odor. The sediment sample collected was organic-rich (at least 20% organics).

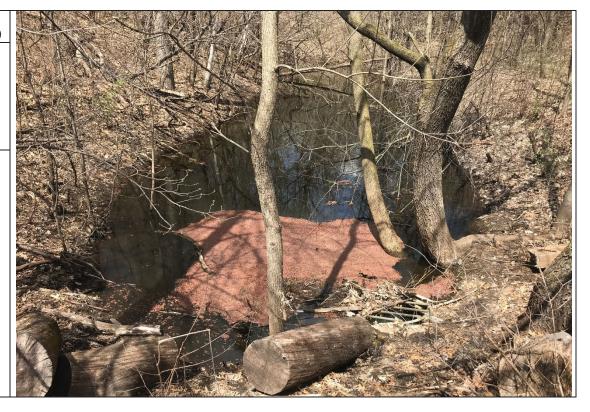
Sediment collected from this sample location consisted of 60% silt, 10% low plasticity clay, 5% medium, sub-rounded gravel, 20% medium sand, and 5% organics.

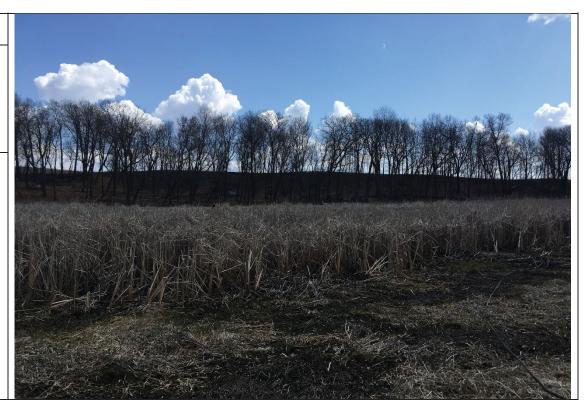
Photo No. 24 **Date:** 4/25/2020

Tall grasses and cattails were observed in the sampling area. Floating algae was also observed in the wetland.

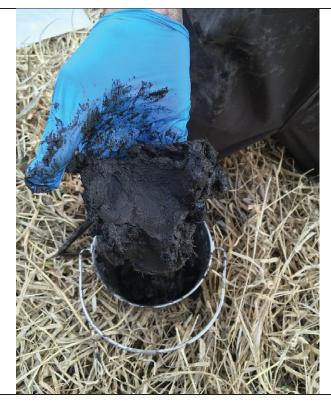
The sediment sample collected from 0-6" in this area consisted of 40% clay, 10% fine sand, and 50% organics.

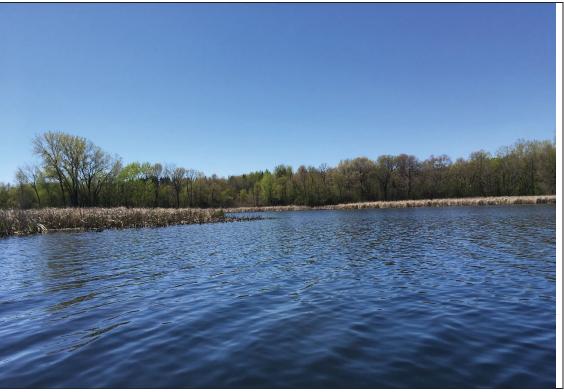
Photo No. 26 **Date:** 5/12/2020

This image shows the sample location at the southern end of Eagle Point Lake. Cattails were observed along the entire shoreline.

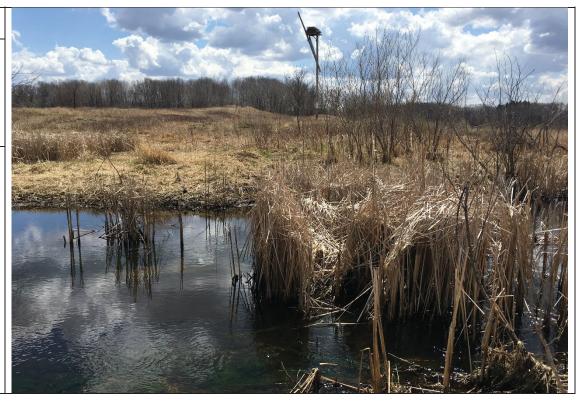
Sediment collected from 0-6" consisted of 75% coarse sand, 5% clay, 15% fine sand, 1% coarse gravel, and 4% organics.

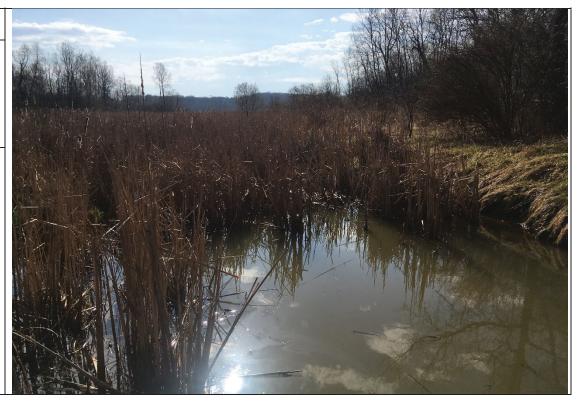
The sediment sample collected from 0-6" at this location consisted of 70% low to medium plasticity clay, 15% coarse angular sand, 10% fine, rounded gravel, 2% medium, subangular gravel, and 3% organics.

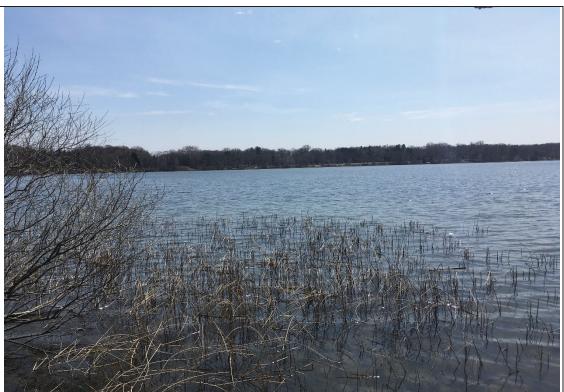
Photo No. 30

High water levels were observed at this sample location on the western shoreline of Lake Elmo. The sediment sample collected from this location consisted of 50% fine sand, 40% medium sand, 5% coarse sand, and 5% silt.

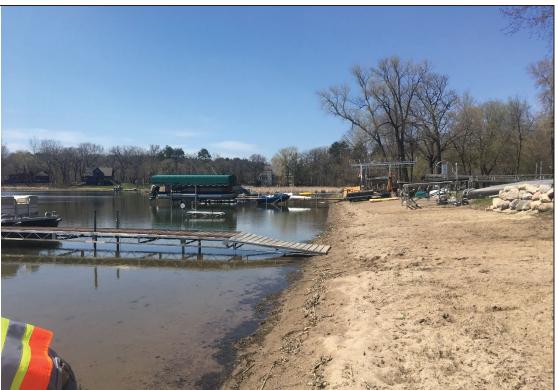
Photo No. 32 **Date:** 4/27/2020

The sediment sample collected from this location consisted of 55% medium sand, 35% coarse sand, 5% fine gravel, and 5% organics.

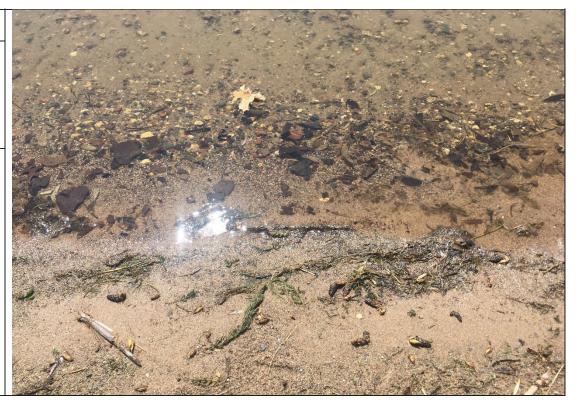
The image shows the texture of the beach sand at this sample location on the northern end of Lake Elmo.

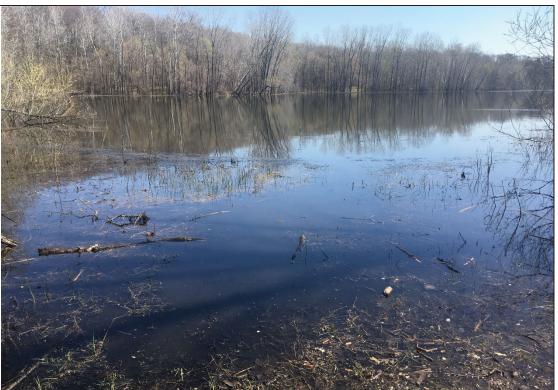
Photo No. 34

The image shows the sample location on the northern end of Sunfish Lake. The sediment sample collected consisted of 70% low plasticity clay, 20% organics, and 10% fine to medium sand.

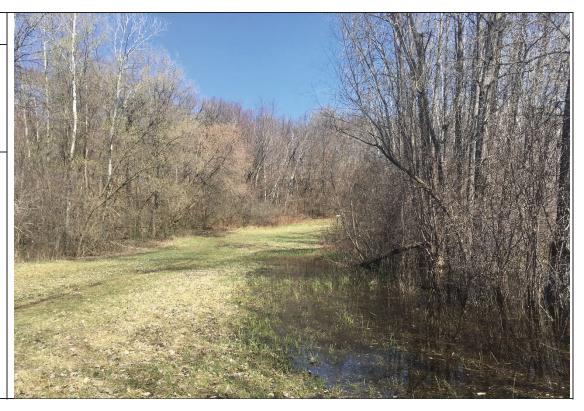
High lake water levels that exceeded the tree line were observed on the northern end of Sunfish Lake.

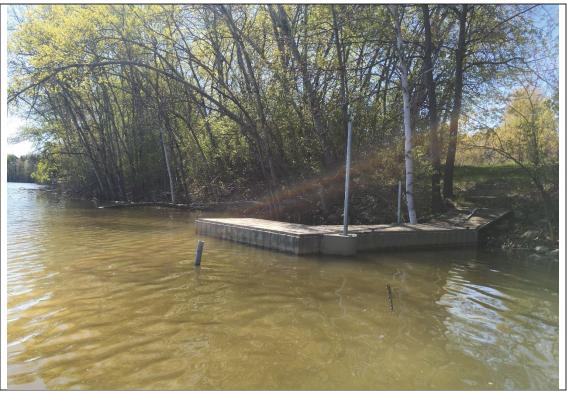
Photo No. 36 **Date:** 5/12/2020

The sediment sample collected from this location consisted of 70% silt, 20% low plasticity clay, and 10% sand.

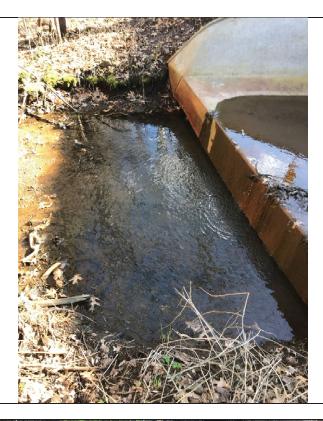
The image shows the culvert that is present at this sample location. Moderate flow was observed throughout the stream but increased near the culvert discharge area. Sediment collected from this location consisted of 60% low to medium plasticity clay, 15% coarse sand, 10% coarse gravel, 5% medium sub-angular gravel, and 5% organics.

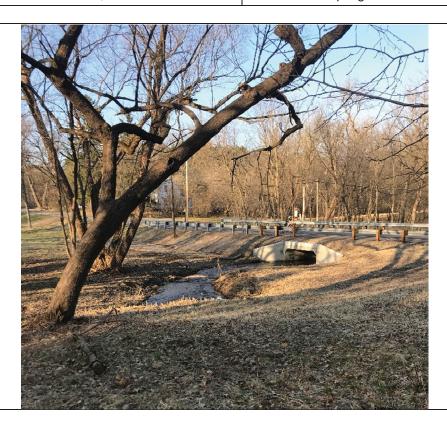
The sediment sample collected from this location consisted of 60% fine to coarse sand, 20% medium plasticity clay, 15% fine, sub-rounded gravel, and 5% organics.
